BLDC Motor to Controller Wire Connection Issues

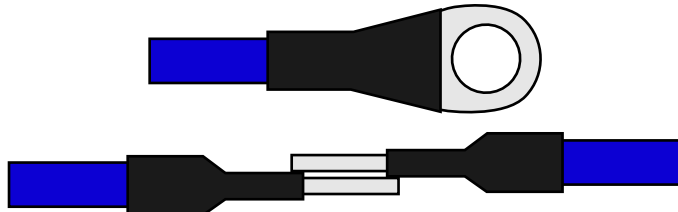
Heat Shrink Too Close to Hole

Condition: Ring terminals connected together by a stud do not make proper electrical connection with each other.

Cause: Factory installed heat shrink tubing too close to the hole of a ring terminal.

Causes Terminals to Not Properly Contact Each Other

Correction: Cut the heat shrink tubing back to an acceptable distance from the hole in the ring terminal.

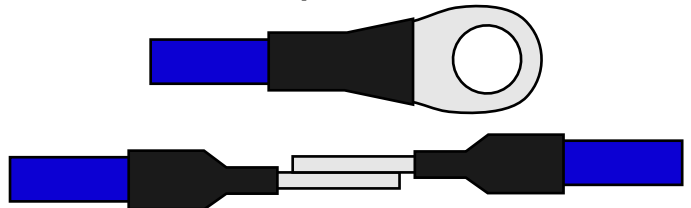
Heat Shrink Acceptable Distance to Hole

Allows Terminals to Properly Contact Each Other

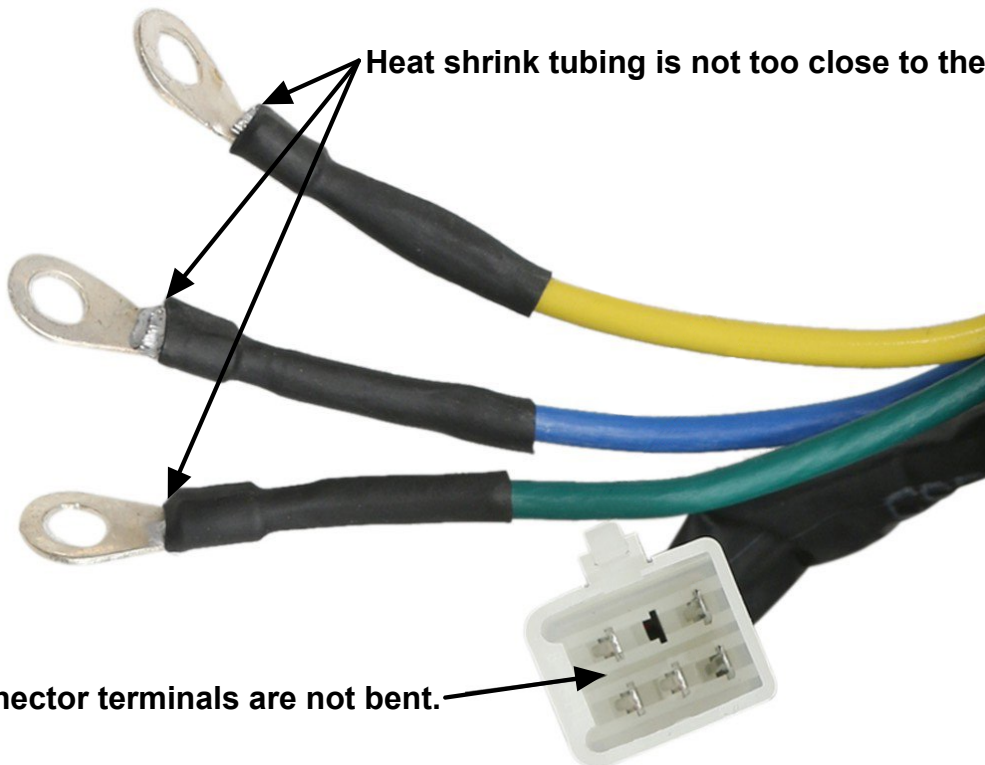
Heat shrink tubing is not too close to the ring terminal holes.

Sensor connector terminals are not bent.
