## MX500, MX650, SX500, Kit Chain Alignment Issue

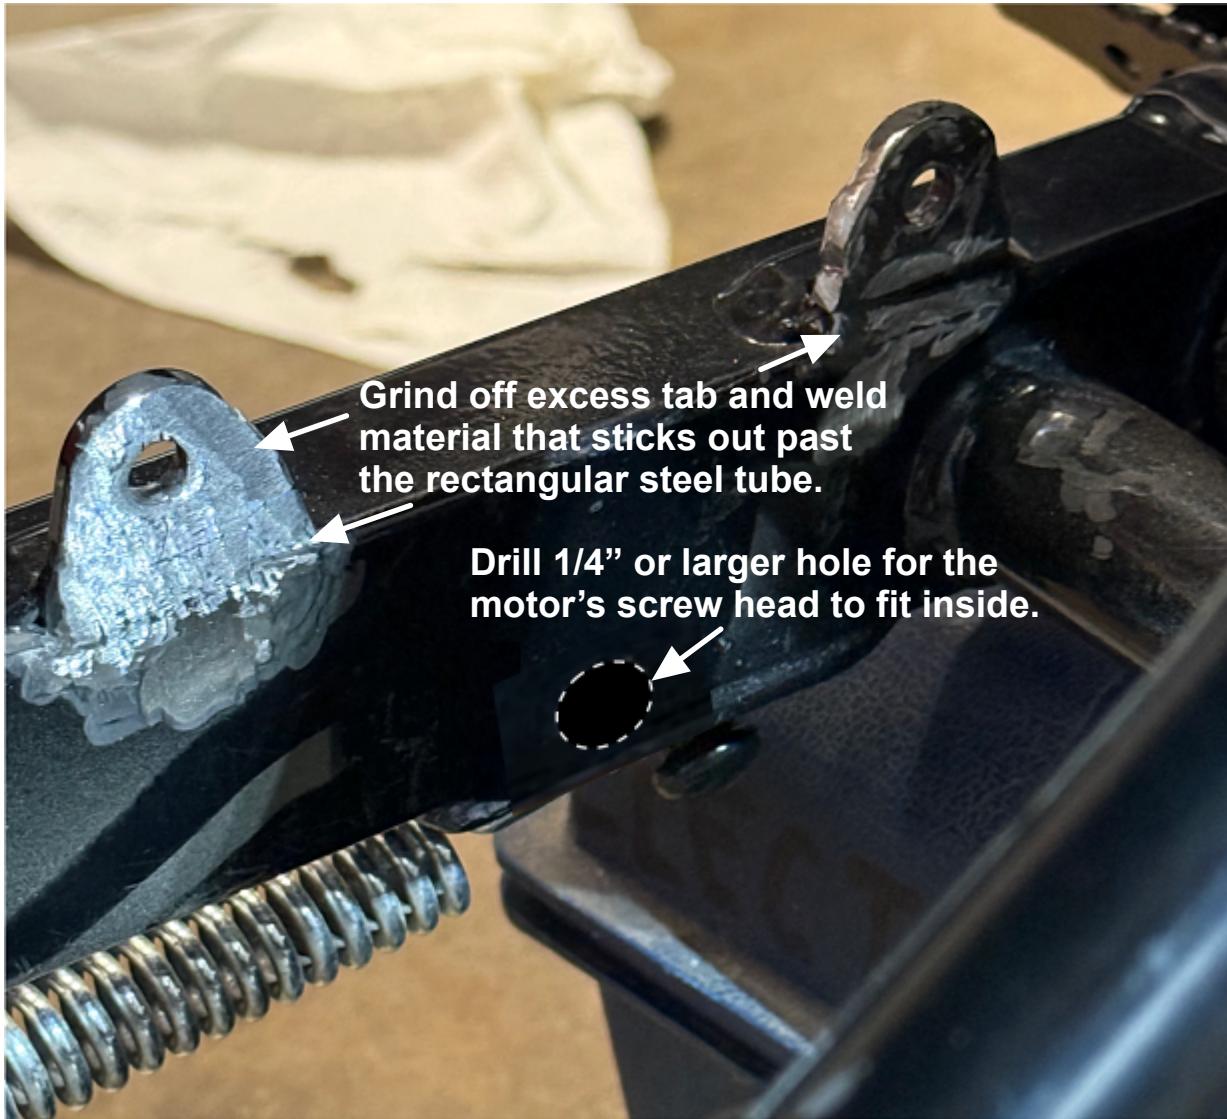
To correct a chain alignment issue with an MX500, MX650, or SX500 kit the issue is commonly caused by the factory misaligning the motor mounting tabs or not grinding off weld material from the motor mounting tabs. This can be corrected by grinding off excess weld material and if necessary grinding the back of the mounting tabs so they are flush with the swing arm. The hole in the swing arm that the motor's bolt head goes into also needs to be sized appropriately so the motor's bolt head fits completely inside of it

Photo of corrections made to the swing arm so the back of the motor fits flush to the swing arm.
