Improper Connection of Ring Terminals with Heat Shrink Tubing

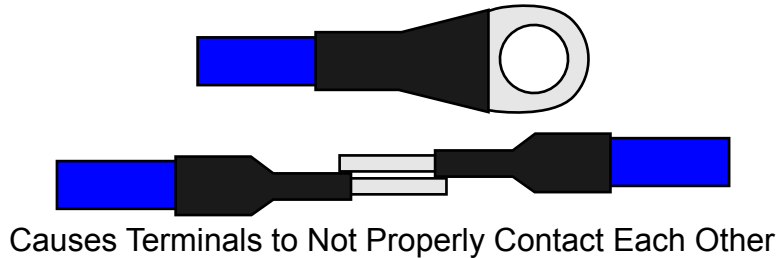
Condition: Ring terminals connected together by a stud do not make proper electrical connection with each other.

Cause: Factory installed heat shrink tubing too close to the hole of a ring terminal.

Heat Shrink Too Close to Hole

Correction: Use a sharp blade to cut the heat shrink tubing back to an acceptable distance from the hole in the ring terminal.

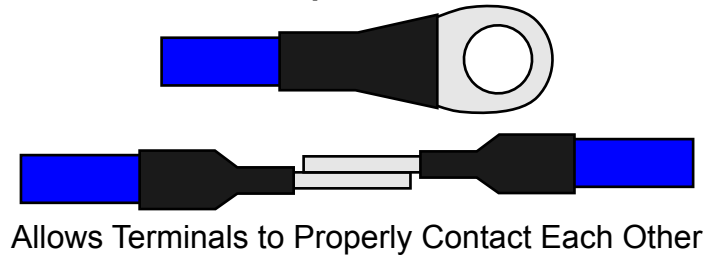
Heat Shrink Acceptable Distance to Hole
